STEP 1: DETERMINATION OF SIGNIFICANCE
STAFF REPORT

Site: 383 Broadway - Garage

Case: HPC.DMO 2021.17

Legal Ad: *Demolish garage*

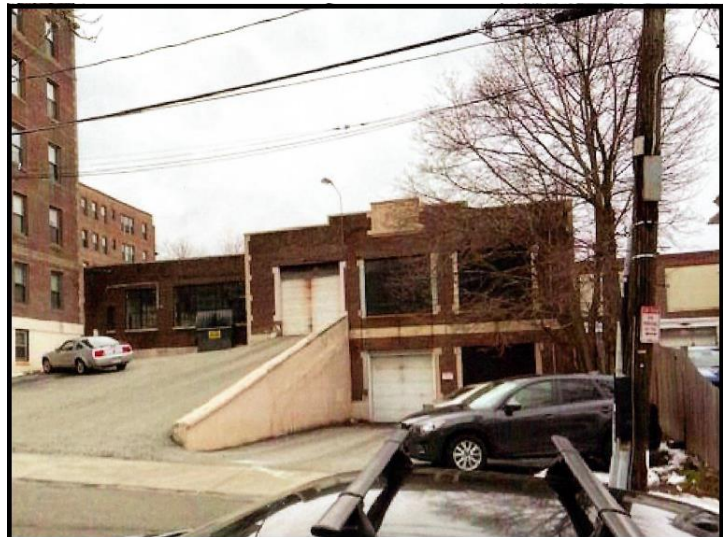
Top: Front elevation

- a. Location: It is likely that this structure is in its original location and was built on-site.
- b. Design: The structure is a flat roofed, brick garage with decorative parapet and stone quoin. Because the property is built on a hill with the front elevation oriented towards the slope, it has an asymmetrical façade with ground floor entrances on both the first and second story. A ramp leads to the entrance on the second floor of the front elevation.

- Flat roof with parapet
 - Stone quoins
 - Front Elevation
 - Asymmetric entrance with one garage door bay on both first and second floor
 - Wood rolling garage doors

- Loading dock entrance on first floor to right of garage door
 - Driveway access to both levels divided by concrete wall
 - Brick siding
 - Stone quoining

- Concrete banding between first and second floors
 - Decorative stone shield detail on parapet
 - Fenestration consists of large pane steel windows, either vertical pivot or projecting elements in center with fixed surrounding panes.

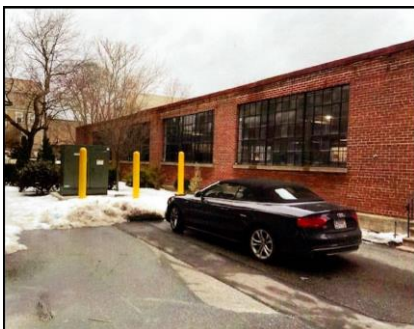
Bottom, left: Left elevation

- Left Elevation
 - One-story
 - Brick with concrete base
 - Fenestration consists of large pane steel windows, either vertical pivot or projecting elements in center with fixed surrounds.
 - Concrete steps
 - 20th-Century iron railings on steps
- Rear Elevation
 - Fenestration consists of large pane steel windows, vertical pivot in center with fixed surrounding panes
 - Two-stories
 - Access door boarded up with wood
 - Concrete siding on first floor
 - Brick siding on second floor

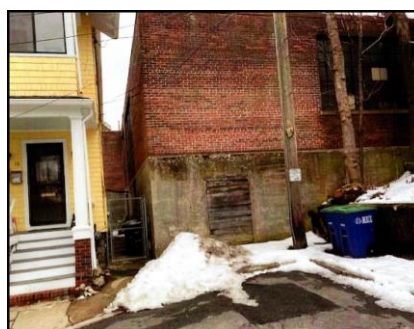
Bottom, middle: Rear elevation

d. Alterations: Enclosure of garage entry bay on right elevation and boarding up of rear access door at street level.

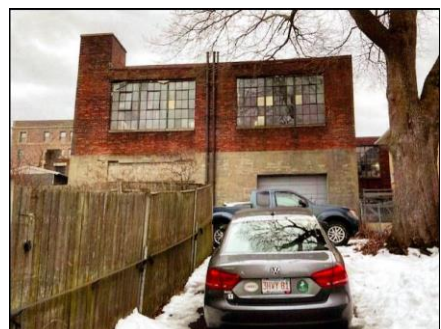
Bottom, Right: Right elevation

- Right Elevation
 - Fenestration consists of large pane steel windows, vertical pivot in center with fixed surrounding panes
 - Two-stories
 - Garage door entryway on first floor on right

- Garage door bay enclosed with masonry
 - Concrete siding on first floor
 - Brick siding on second floor

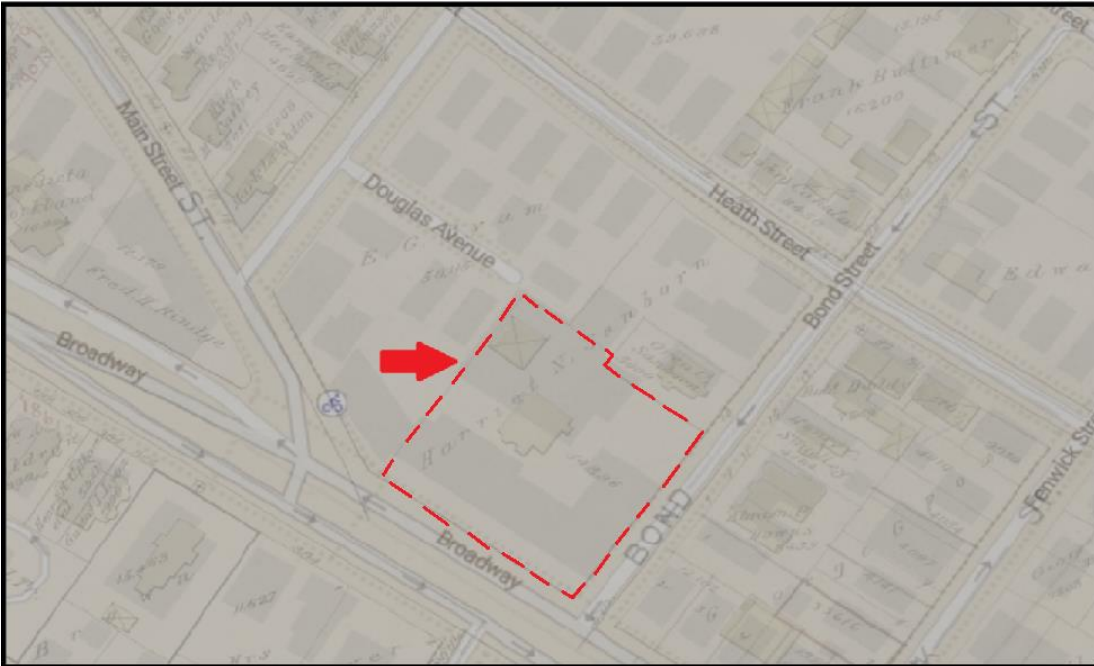
Below is the 1895 Bromley Map overlayed with the location of current properties. The location of the garage at today's 383 Broadway is depicted in comparison to the Sanborn family's original plot and home

Left:
Overlay of
1895
Bromley
Map,
Plate 12,
with 2021
GIS map
Indicated-
1895 lot.

1938-1959 Sanborn Map depicts the current garage at 12 Bond St and apartments at 383 Broadway. Based on the 1895 Bromley Map and the 1938-1959 Sanborn Maps, we can determine between 1895 and 1926 the two original???structures on the land that currently comprise 383 Broadway were demolished and subdivided in to two lots.
